Third Party Inspection Report

INSPECTION REPORT Nr. IND 20-213-01	Revision Nr.0
<input type="checkbox"/> Initial <input type="checkbox"/> Interim <input checked="" type="checkbox"/> Final <input type="checkbox"/> Resident	
Inspection requested by: Tech Vice Co.,Ltd.	
Inspection performed as Recognized Authority: <input type="checkbox"/> Yes, :(Recognition) <input checked="" type="checkbox"/> No	
BV Job Nr: IND 20-213 rev.01

Project: Seamless tube Inspection	IPO Ref (If applicable): N/A <i>(BV internal P/o)</i>
BV Client: Tech Vice Co.,Ltd.	P/o nr: N/A <i>(client to BV)</i>
Manufacturer/Vendor: Shandong Jianshou Steel Co., Ltd.	P/o nr: N/A <i>(client to Manufacturer)</i>
Sub-Vendor (If applicable): N/A	
Inspection Location: Haitong Logistics park, liao cheng city, Shandong province	Previous Inspection (If applicable): N/A <i>(Date)</i>
Inspection performed on: 19 th Sep,2020 <i>(Date(s))</i>	Next Inspection (If applicable): TO BE INFORMED <i>(Date)</i>

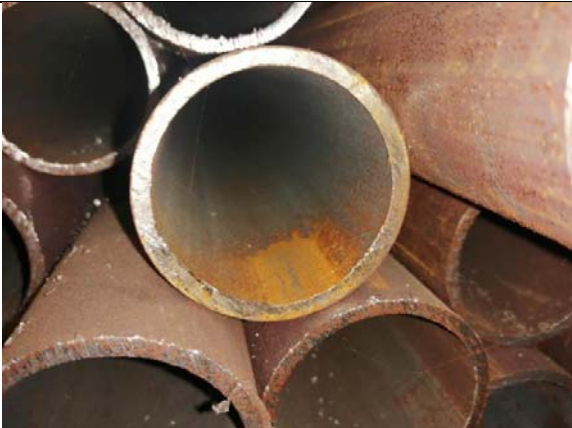
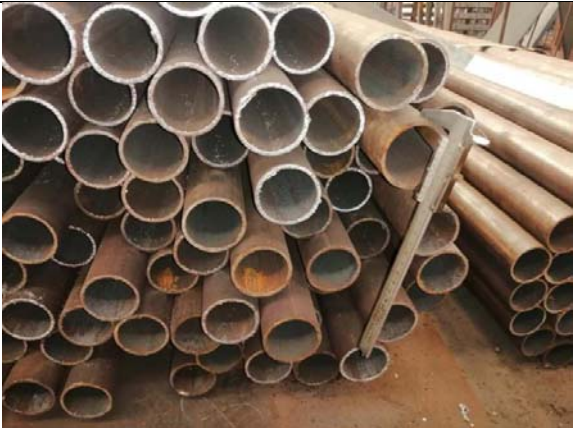
Inner surface and outer surface for each tube is slightly rusted. The vendor refused to repair the rust.

<p>Visual inspection (Inner surface is slightly rusted)</p>	<p>Visual inspection (Inner surface is slightly rusted)</p>

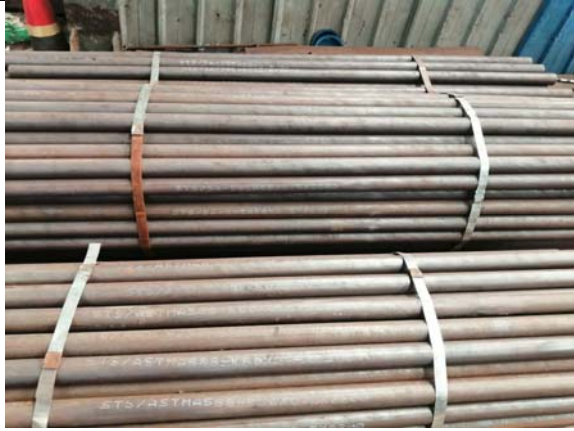
Visual inspection (Outer surface is slightly rusted)

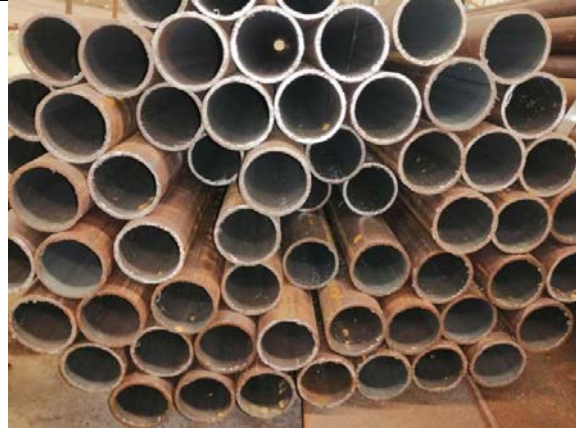
Visual inspection (Outer surface is slightly rusted)
