Third Party Inspection Report

INSPECTION REPORT Nr . IND 20-213-03	Revision Nr.0
<input type="checkbox"/> Initial <input type="checkbox"/> Interim <input checked="" type="checkbox"/> Final <input type="checkbox"/> Resident	
Inspection requested by: TechVice	
Inspection performed as Recognised Authority: <input type="checkbox"/> Yes, :(Recognition) <input checked="" type="checkbox"/> No	
BV Job Nr: IND 20-213-01

Project: Seamless tube Inspection	IPO Ref (If applicable): N/A (BV internal P/o)
BV Client:/	P/o nr: N/A (client to BV)
Manufacturer/Vendor: Shandong Jianshou Steel Co., Ltd.	P/o nr: N/A (client to Manufacturer)
Sub-Vendor (If applicable): N/A	
Inspection Location: Haitong Logistics park,liaocheng city, Shandong province	Previous Inspection (If applicable): 26 th Oct.2020 (Date)N/A
Inspection performed on: 21 st Nov 2020 (Date(s))	Next Inspection (If applicable): (Date)TBA

MATERIAL / SUBJECT OF INSPECTION	ITEM / TAG Nr	QTY As per P/O	QTY Offered for inspection
<input type="checkbox"/> Refer to attachment section J instead (Indicate if separate material list is provided in attachment)			
SEAMLESS TUBE ASTM A588-K(Q310GNHA) L2200*OD.60*WT2MM	3	3630 pcs	3630 pcs

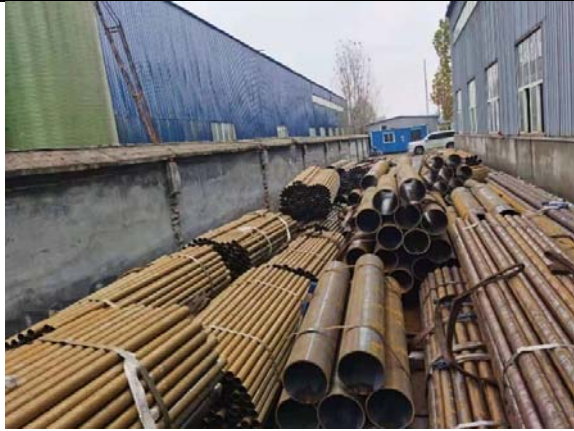
Note: Inside and outside surface for 40 pcs of tube is rusted. Almost 80% of all pipes has rusted on the outside and inside surface. The vendor won't repair the rust.

Visual inspection (rusted on the outside and inside surface)

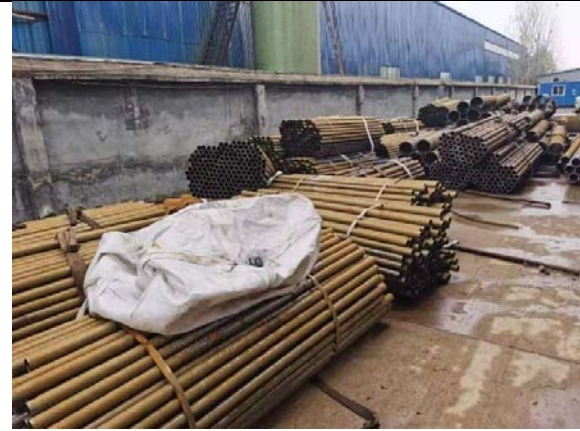
Visual inspection (rusted on the outside and inside surface)

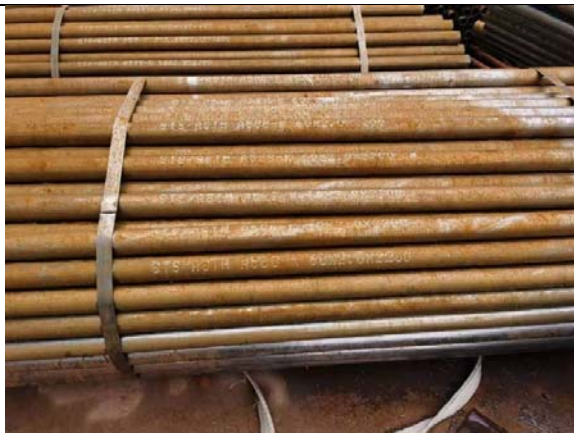
Visual inspection (rusted on the outside and inside surface)

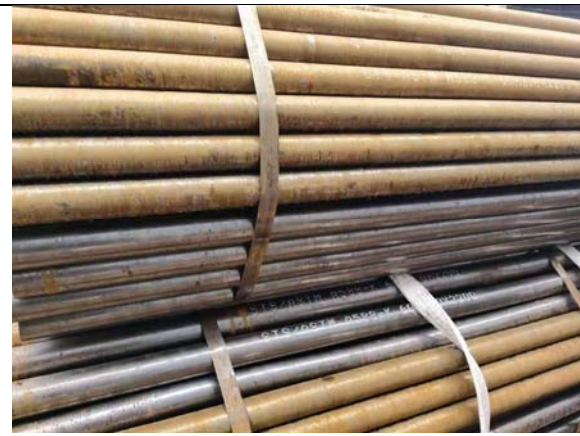
Visual inspection (rusted on the outside and inside surface)

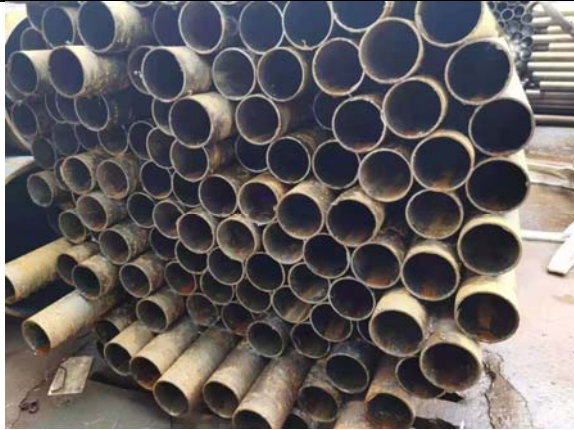
Visual inspection (rusted on the outside and inside surface)

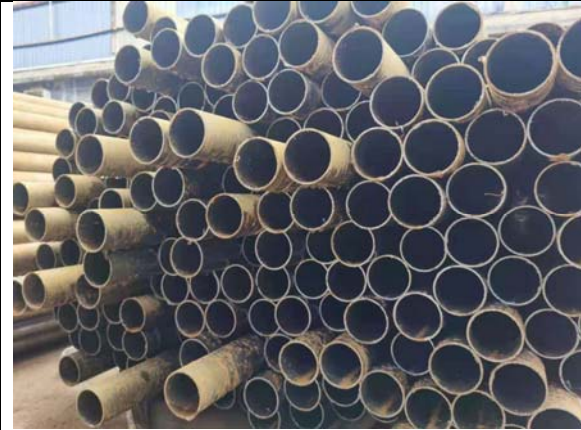
Visual inspection (rusted on the outside and inside surface)

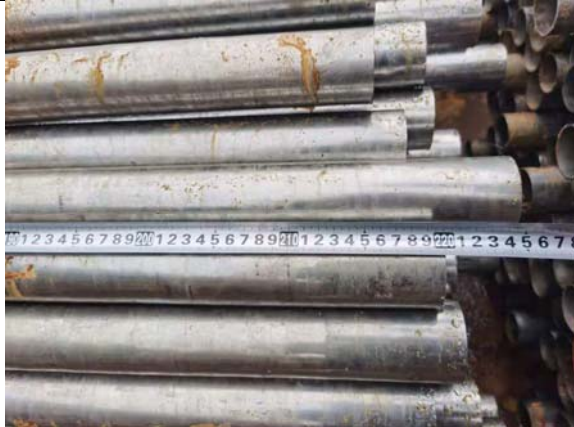
Dimensional inspection

Tag	Inspected Qty.	OD (mm)	Wall thickness (mm)	Length (mm)	Result
3	50pcs	59.8~60.3mm	1.97~2.02mm	2195~2204mm	/

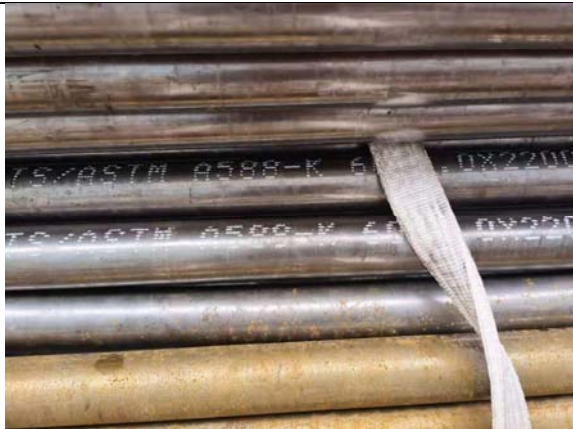
Marking inspection

STS/ASTM-A588-K 60x2.0x2200
